Precise SD™ Distal Radial Volar Plate

Treatment of Distal Radius Fractures Utilizing the Precise SD Distal Radial Volar Plating System: A Case Series

Michael Shuler, MD
Upper Extremity Surgeon
Athens, Georgia

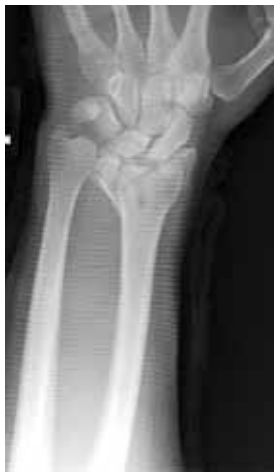
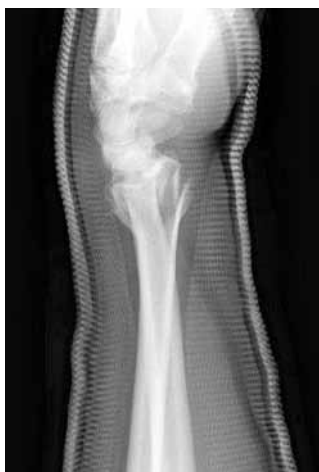
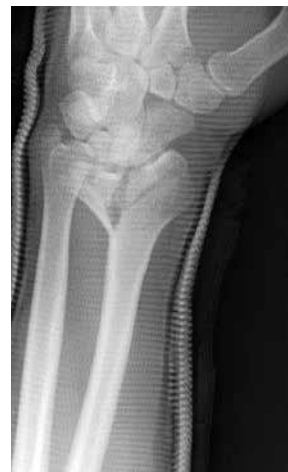
Three views were taken of the wrist, including an AP, Lateral and Oblique view. Radiographs showed a left distal radius fracture with significant intra-articular comminution, loss of radial height, dorsal tilt of approximately 30°, and lunate facet displacement. A small associated ulnar styloid fracture was present as well. (Figures 1-3)

The patient was diagnosed with a comminuted, intra-articular, unstable left distal radius fracture with loss of radial height and volar tilt as well as ulnar styloid fracture.

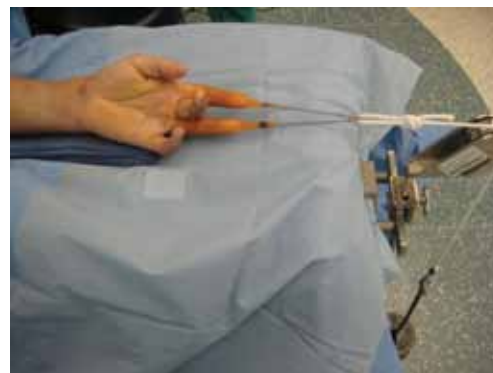
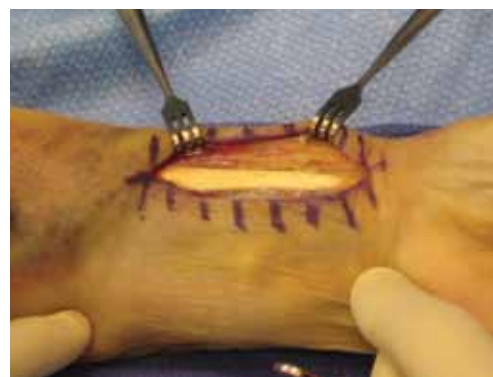
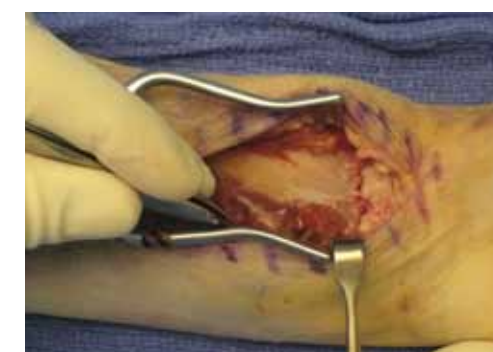
A longitudinal incision was made over the flexor carpi radialis. Blunt dissection was made down to the flexor carpi radialis. The sheath was incised longitudinally **(Figure 5)**. The tendon was reflected ulnarly, and the dorsal sheath was then incised. Blunt dissection was then made down to the pronator quadrates by reflecting the flexor mass ulnarly. A blunt self retainer was used to maintain the exposure. A blunt retainer was used to prevent inadvertent injury to the median nerve or radial artery. The pronator quadratus was then exposed and sharply released off the distal and radial aspects of the distal radius exposing the fracture site **(Figures 6 & 7)**. The brachioradialis was also released off the radial styloid to allow for reduction of the styloid fragments. The complete Surgical Technique can be downloaded from www.totalsmallbone.com ref# MKT31010.

The articular surface was then reduced through direct manipulation and confirmed with fluoroscopic imaging. A freer was used to tamp the articular surface into position. Once the fracture was reduced, specifically the articular surface, two 0.54 radial styloid pins were placed from the radial styloid through the subchondral bone to maintain the reduction of the articular surface. (In cases where the pins may be required to maintain or supplement the fixation for an extended period, titanium K-wires are recommended to prevent any possible metal interactions.)

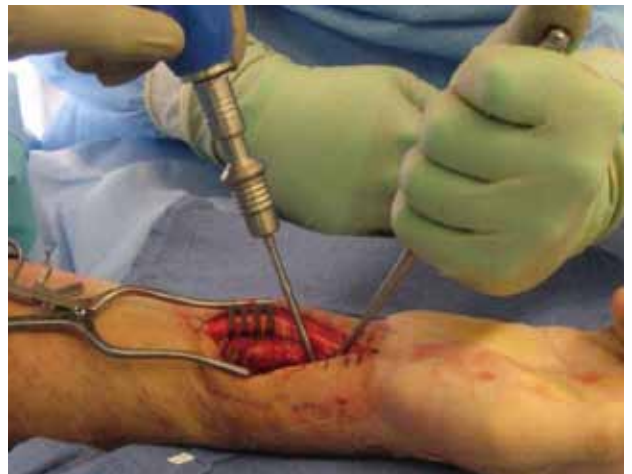
Once plate placement was confirmed, the distal screws were placed in a locking fashion. A key elevator was used to place a volar to dorsal force on the plate. (Figure 9) This maneuver allows for the plate to be placed flush against the volar aspect of the distal radius and prevents the plate from being too prominent distally which may cause flexor tendon irritation. Additionally, a blue towel was rolled and placed underneath the distal wrist to allow for some restoration of the volar tilt. When the radial styloid is displaced or there is a sagittal split in the articular surface, compression by squeezing the radius towards the ulna can help reduce this split while drilling and placing the distal screws.

Placement of the distal screws is facilitated by the predesigned drill guide. This guide allows for safe placement of screws when the plate is appropriately aligned. The distal screws are generally angulated in a radial fashion. However, a unique benefit of the Precise System allows the guide to be removed and the screws placed in a freehand manner. This feature was utilized in this case to ensure the lunate facet was stabilized. The two most ulnar screws were placed freehand and directed toward the sigmoid notch (Figure 10).

The plate was set in a position where the proximal aspect of the plate is maintained off the radial shaft by about 1 cm. A freer is placed under the plate between the plate and the volar cortex of the radial shaft to prevent the proximal plate from being compressed to the radius inadvertently. By maintaining the plate off the radial shaft, it allows for restoration of the volar tilt once the distal fragments are stabilized and the plate is compressed down to the radial shaft.

Once confirmed with fluoroscopic imaging, two K-wires were then driven through the guide holes in the plate – one through the distal aspect of the plate and another through the proximal aspect of the plate on the radial edge of the plate. The K-wires were cut in half to allow for easy fluoroscopic imaging. (Figure 8) Two folded towels were placed underneath the wrist in case a K-wire or drill bit is inadvertently driven through the dorsal skin. This measure will prevent sharp objects from penetrating the drapes and disturbing the sterile field.

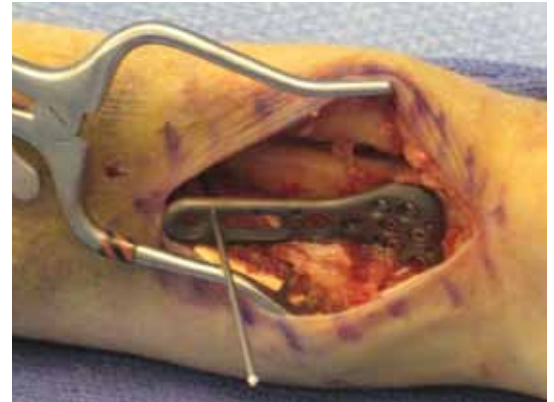
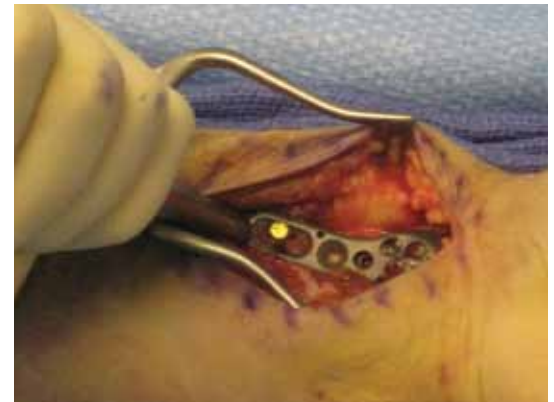
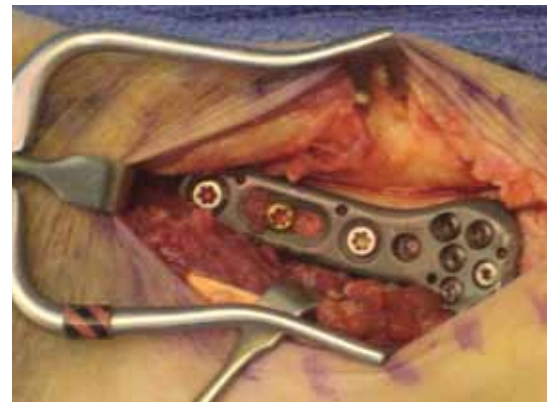
There are technique tips that can prevent potential problems in this maneuver. First the drill hole for the oblong hole needs to be drilled perpendicular to the plate (not necessarily perpendicular to the cortical surface). If the screw is not placed perpendicular to the plate, the head can slip through the hole and require distal screw and plate removal to retrieve the screw. The hole is drilled with the proximal pin in place. The screw is started but not tightened. Once the screw has been started, the proximal K-wire is removed from the guide hole in the plate. The guide wire is placed in an oblique (ulnar) direction and can prevent plate compression to the radius if it is not removed. However, it is easiest to get the screw started prior to removing the K-wire. This order will also prevent loss of reduction of the distal radius on the radial shaft. Traction is also released from the wrist once the first shaft screw is provisionally placed. Lastly, a bone tamp is used to manually compress the plate to the radial shaft in order to assist in plate compression and prevent the screw from slipping through the hole in the plate (**Figure 12**).

Once the compression screw was placed, it was tightened down. Fluoroscopic images were checked to confirm the restoration of the articular surface and the volar tilt. Two additional locking screws were then placed – one in the most proximal screw hole and one in the distal shaft hole (**Figure 13**). Once the

screws were in place, fluoroscopic images confirmed a well reduced distal radius with restoration of the articular surface, volar tilt as well as radial height. The two provisional subchondral K-wires were removed as they were not needed to maintain stability. Prior to closing, the DRUJ stability was assessed using a volar and dorsal stress in supination, neutral and pronation. In this case, the distal radioulnar joint (DRUJ) was stable to stress and the ulnar styloid was not addressed.

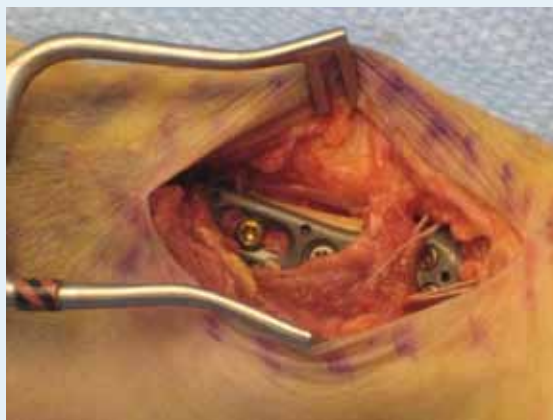
Figure 14

The wound was irrigated. The pronator quadratus was tacked over top of the plate using 2.0 vicryl suture (**Figure 14**). Care needs to be taken to prevent injury to the radial artery when repairing the pronator quadratus. Typically, a grasping stitch is required to get an adequate repair of the muscle. The volar flexor carpi radialis sheath was closed using 4.0 vicryl to prevent adherence to the skin. The skin was closed using 4.0 nylon. The wound was then dressed using xeroform gauze, sterile 4x4s, sterile cast padding and a sugar-tong splint was placed in full supination. Supination is preferred to reduce the pull of the brachioradialis on the styloid. It helps maintain stability of the DRUJ. Lastly, supination is typically the hardest motion to obtain in these injuries Post-Operatively; therefore, two weeks in supination can assist in regaining this motion. Finger motion is encouraged from Post-Operative day one.

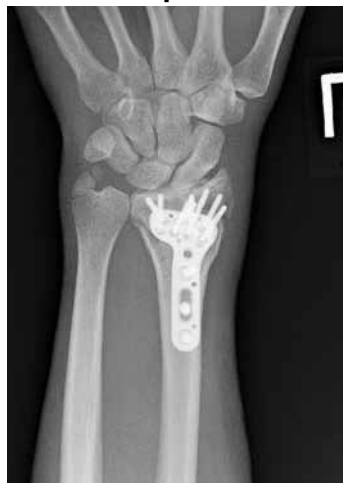
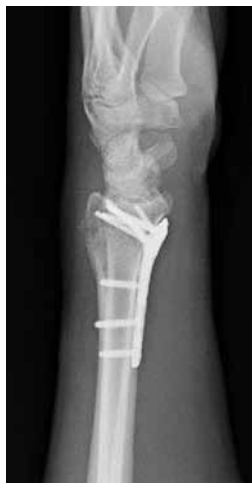
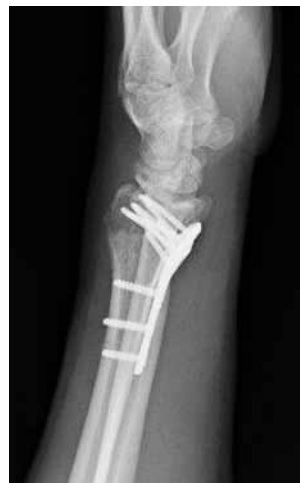
Post-Operatively, the patient was seen back in clinic approximately one week after surgery due to pain and irritation of the skin. The splint was removed, and it was determined the patient had a reaction to the cast padding and was changed over to an orthoplast splint for an additional 4 weeks. Typically, patients are splinted for two weeks followed by casting for an additional 3 weeks. Sutures were removed at 2 weeks. (**Figures 15-17**) Range of motion activities for the hand and forearm rotation were begun under guidance of an occupational therapist starting at 2 weeks Post-Operatively. At 5 weeks Post-Operatively, the patient was given an off the shelf Velcro removable splint and instructed to use this on an as needed basis for comfort. Wrist activities including flexion and extension exercises were initiated at this time. Wrist motion can begin earlier, but typically patients do not participate in wrist activities until their pain has subsided. Therefore, patients are supported with splints / casts until 5 weeks Post-Op when pain is less significant.

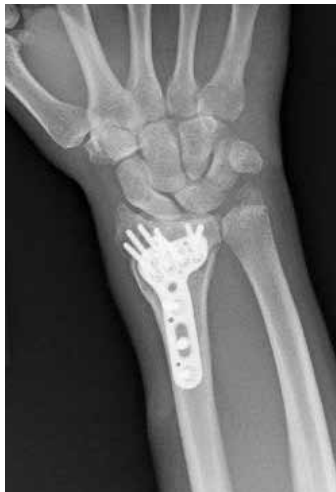
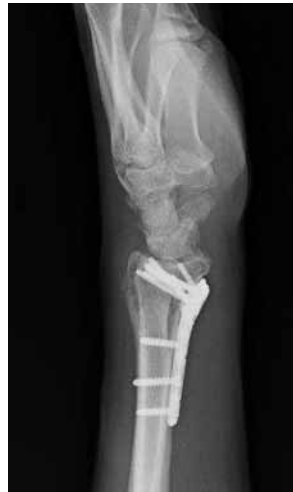
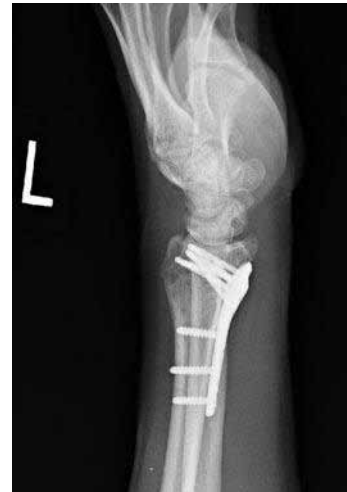
The patient was then seen back in clinic approximately 3 months after surgery – good boney healing was confirmed at that time (**Figures 18-20**). After full boney union, plate removal was discussed with the patient, and he elected to have it removed. The plate was removed at approximately 5 ½ months Post-Operatively. Final radiographs after plate removal showed a well healed distal radius fracture with restoration of the articular surface, radial inclination, radial length and volar tilt (**Figures 21-23**). Range of motion at final follow up was approximately 80° flexion and approximately 80° of extension. Additionally, he had 80° of supination and pronation. He had no pain within any range of motion. He had returned to full activity including mountain biking and kayaking.

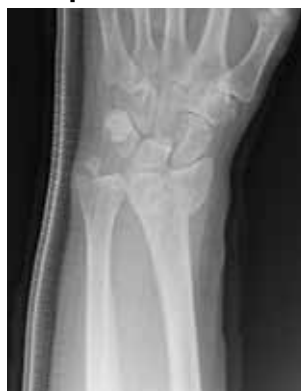
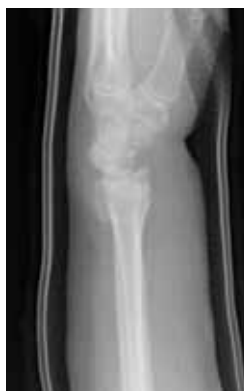
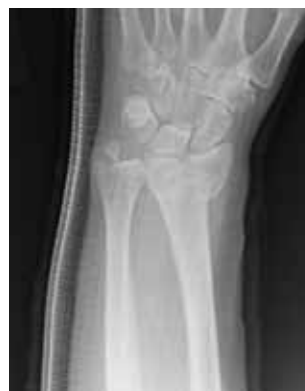
Three views of the wrist were obtained that showed an intra-articular distal radius fracture with dorsal comminution, loss of radial height as well as dorsal tilt of approximately 15°. A concomitant ulnar styloid fracture was also seen. **(Figures 1-3)**

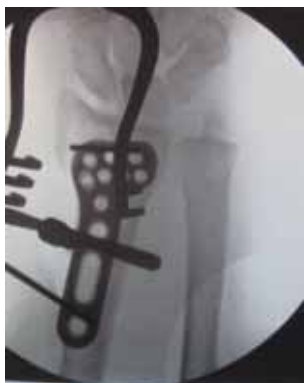
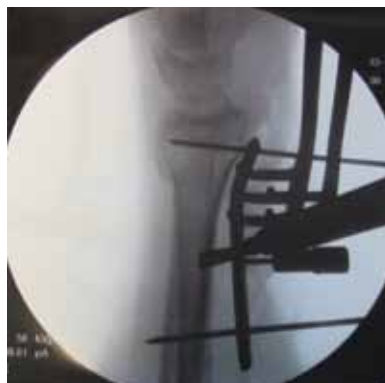
The Precise SD plate was positioned over the fracture. Two K-wires were used to maintain the position – one distally and one proximally. Once positioned, the plate was maintained proximally off the radial shaft approximately 15° of angulation to allow for restoration of the volar tilt. (**Figures 4 & 5**) A freer was positioned underneath the plate in between the distal radius and the plate to maintain the plate off the radius. The proximal K-wire was then driven through the plate into the bone to maintain the height of the plate off the radial shaft.

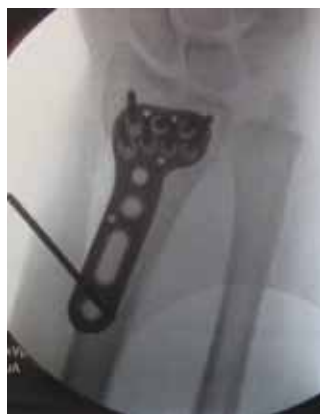
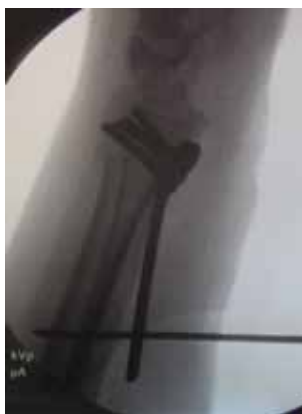
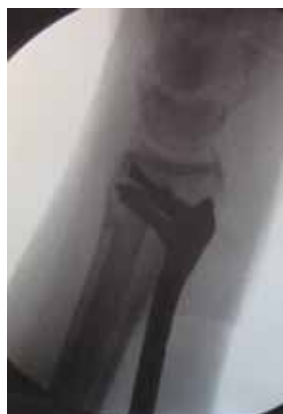
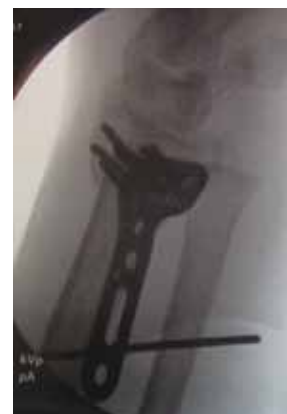
Fluoroscopic imaging is checked to confirm adequate placement of the distal screws. As previously mentioned in Case #1, four views are recommended to confirm placement and ensure the screws are not too long or in the joint. A standard AP and Lateral view are obtained (**Figures 6 & 7**). Next an elevated Lateral is obtained where the hand is raised off the hand table approximately 20° in order to image the joint down the radial inclination. (**Figure 8**). Lastly, a 45° supination view is obtained to ensure the radial styloid screws are not too long and protruding out the dorsal cortex (**Figure 9**).

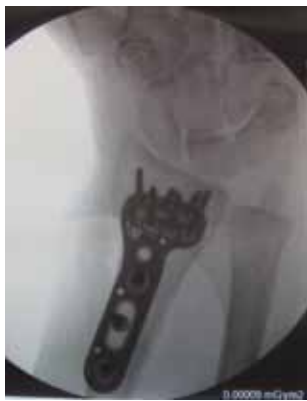
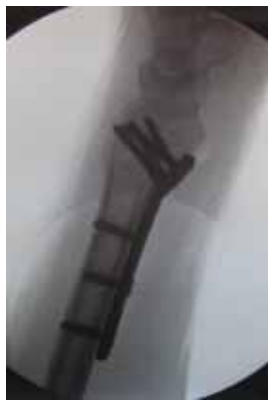
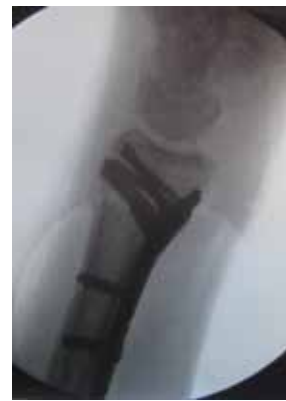
Next the compression screw was tightened down. Fluoroscopic images were checked to confirm the restoration of the articular surface and the volar tilt. Two additional locking screws were then placed – one in the most proximal screw hole and one in the distal shaft hole. Once the screws were in place, fluoroscopic images confirmed a well reduced distal radius with restoration of the articular surface, volar tilt as well as radial height. **(Figures 10-12)** Prior to closing, the DRUJ stability was assessed using a volar and dorsal stress in supination, neutral and pronation. In this case, the DRUJ was stable to stress and the ulnar styloid was not addressed.

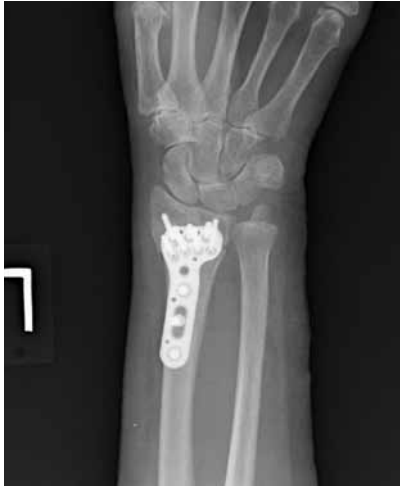
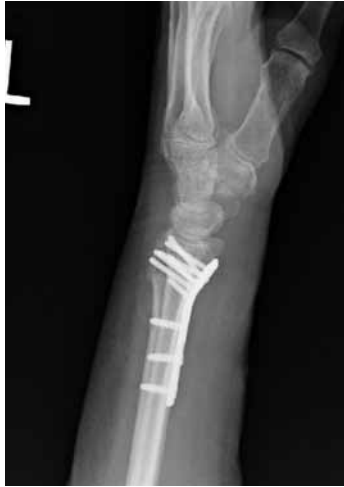
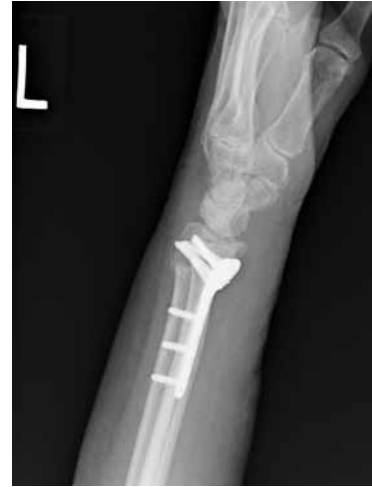
The patient was seen in clinic approximately 2 weeks after surgery where the sutures were removed. **(Figures 13-15)** The splint was changed to a short arm cast for an additional three weeks. Range of motion exercises were begun at the two week point supervised by an occupational therapist, to work on finger motion as well as forearm rotation. At 5 weeks, the patient was converted to a removable off-the-shelf Velcro splint, which she was to wear on an as-needed basis for comfort. At approximately six months after the injury, she was determined to be well healed based on radiographic findings. The patient elected to have the hardware removed after discussing the risks and benefits of removal versus retaining the hardware. Removal is considered once radiographic union is confirmed. If radiographic union is in doubt, a CT scan can help confirm union prior to plate removal.

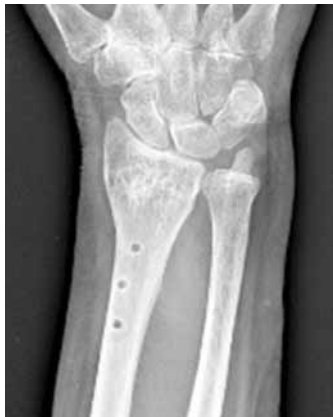
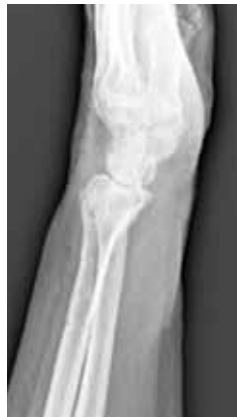
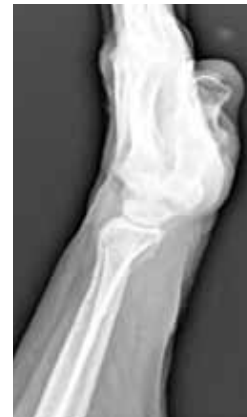
Final radiographs show a well healed distal radius fracture with restoration of the articular surface, radial inclination, radial height and volar tilt. **(Figures 16-18)** At final follow up, the patient had 75° of extension and 90° of flexion. She had full supination and pronation of 90°. She was able to perform her daily activities without pain.

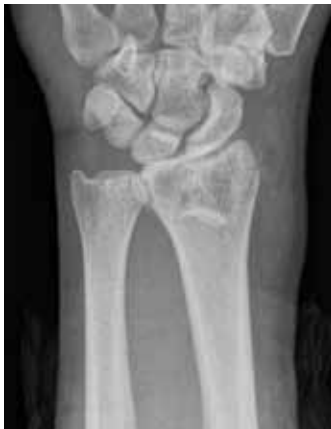
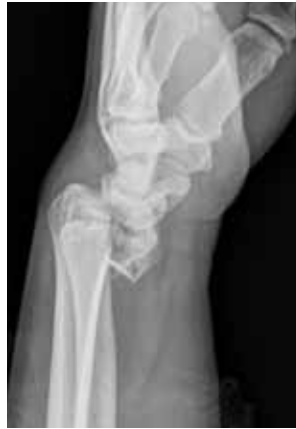
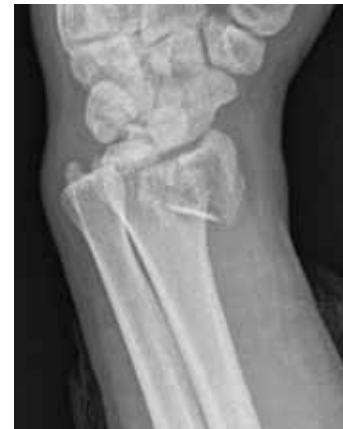
The patient is a 35 year old right hand dominant male involved in a motorcycle accident. He was seen and evaluated in a local emergency department where he was diagnosed with a left severely comminuted intra-articular volar Barton's fracture with carpal subluxation. (Figures 1-3) The patient was provisionally reduced and splinted.

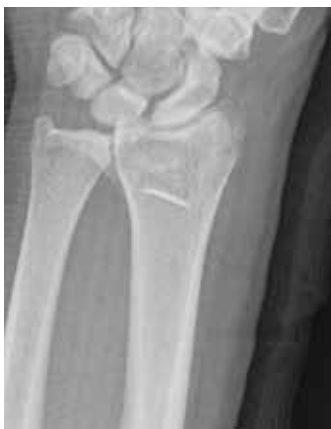
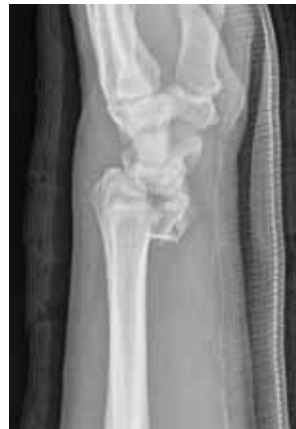
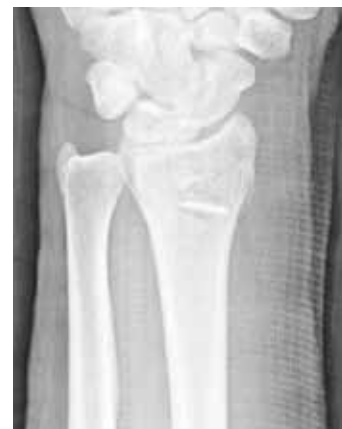
Three views of the left distal radius showed a severely comminuted volar Barton's fracture with carpal subluxation. (Figures 4-6)

Left severely comminuted volar Barton's distal radius fracture with carpal subluxation as well as carpal tunnel syndrome.

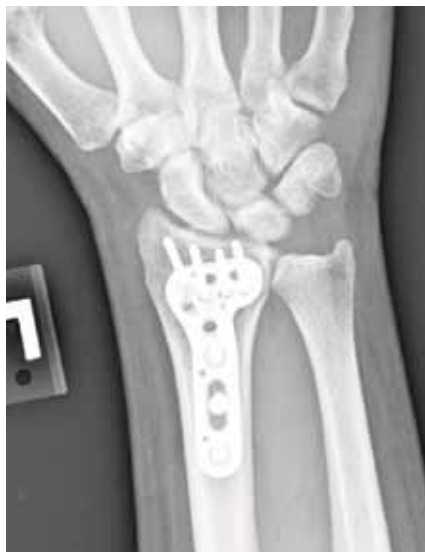
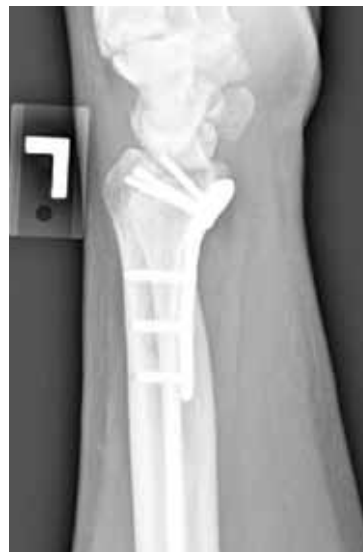
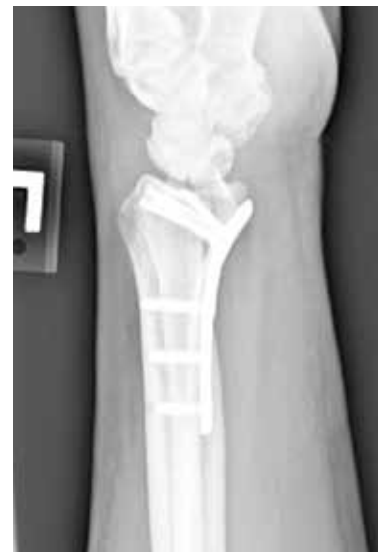
The patient was seen back at two weeks and transitioned into a short arm cast. He began to work on supination and pronation exercises after two weeks. Radiographs showed well placed hardware with restoration of the joint surface and carpal alignment. **(Figures 7-9)** After five weeks, the patient was converted to a removable splint and allowed to begin range of motion activities with flexion and extension. Radiographs at 5 weeks Post-Op showed early bone healing and continued maintenance of alignment. **(Figures 10-12)**

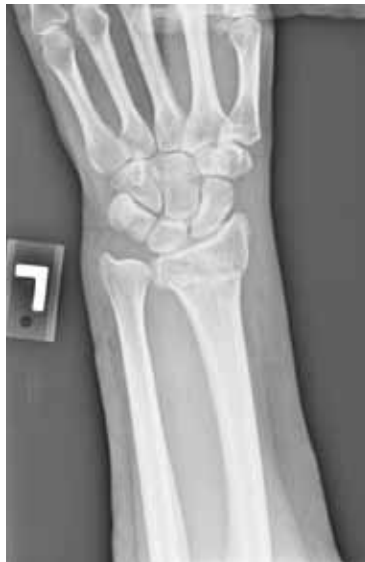
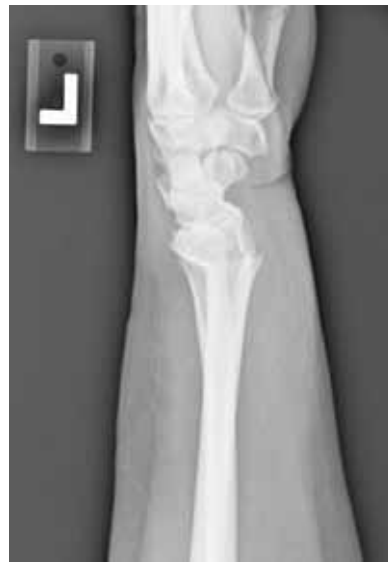
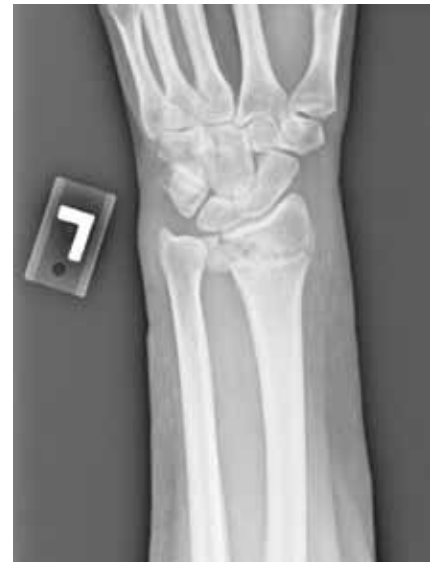
Three views of the wrist were obtained that showed an intra-articular distal radius fracture with dorsal comminution, loss of radial height as well as dorsal tilt of approximately 25°. The lunate facet was also fractured and displaced on the Oblique view. **(Figures 1-3)**

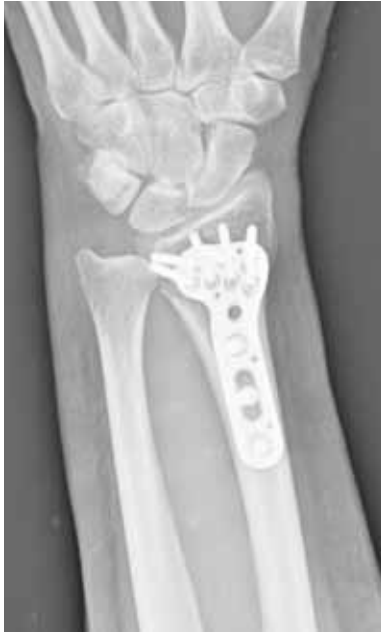
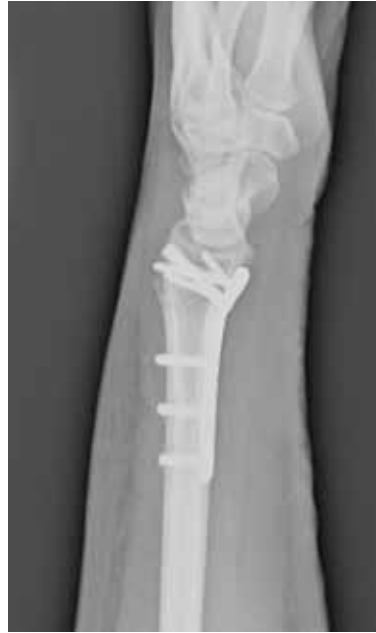
The patient was seen in clinic approximately 2 weeks after surgery where the sutures were removed. **(Figures 4 & 5)** The splint was changed to a short arm cast for an additional 3 weeks. Range of motion exercises were begun at the 2 week point, supervised by an occupational therapist, to work on finger motion as well as forearm rotation. At 5 weeks, the patient was converted to a removable

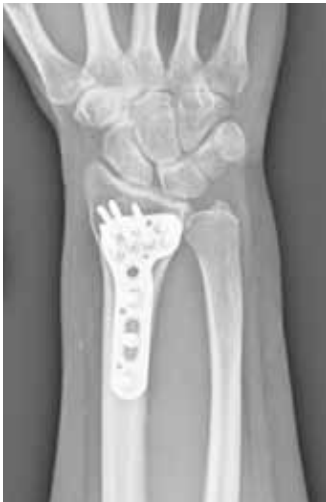
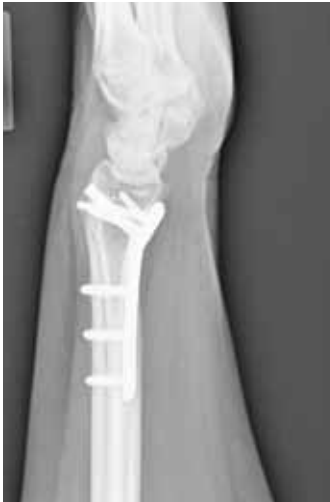
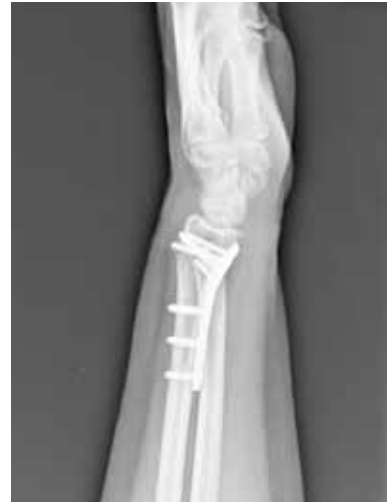
off the shelf Velcro splint which she was to wear on an as needed basis for comfort. (Figures 6-8) At approximately six months after the injury, she was determined to be well healed based on radiographic findings. The patient elected to have the hardware removed after discussing the risks and benefits of removal versus retaining the hardware.

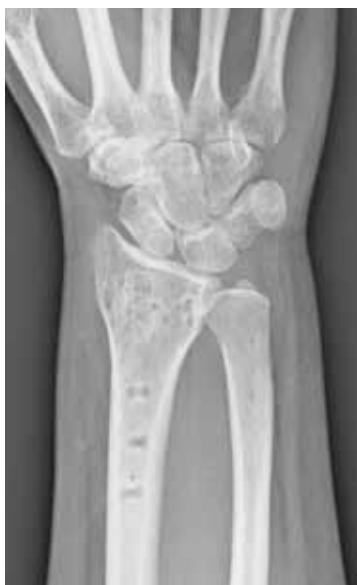
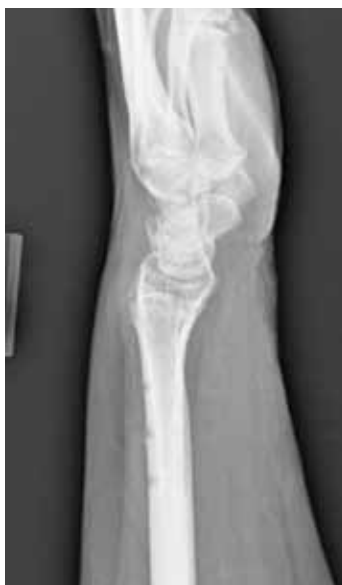
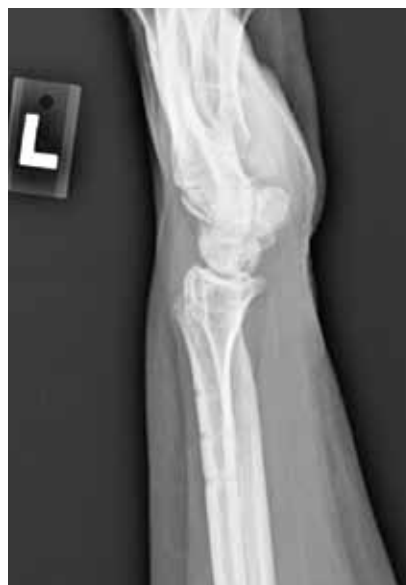
Final radiographs show a well healed distal radius fracture with restoration of the articular surface, radial inclination, radial height and volar tilt. **(Figures 9-11)** At final follow up, the patient had 85° of extension and 80° of flexion. She had full supination and pronation of 90°. She was able to perform her daily activities without pain.
